MERRIMACK RIVER BASIN
WESTMINSTER, MASSACHUSETTS

MEETINGHOUSE POND DAM
MA 01018

PHASE I INSPECTION REPORT
NATIONAL DAM INSPECTION PROGRAM

NOVEMBER 1978

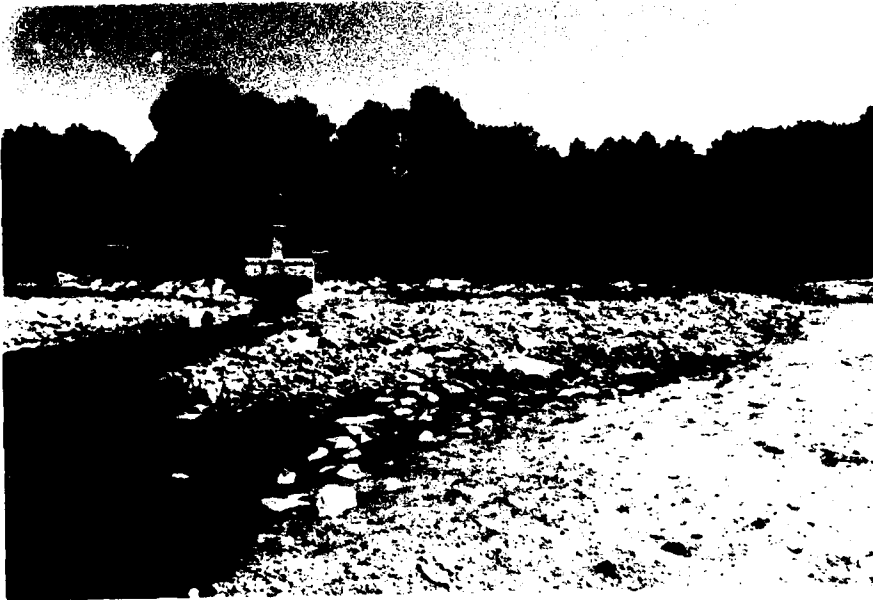
1. OVERVIEW OF MAIN DAM AND GATE HOUSE.

- c. Appurtenant Structures - The gate house shown in Photo Nos. 1 and 2 is in good condition. The wood trim on the structure requires maintenance and repainting. The parge coat at the base of the structure has some cracking present. The equipment shown in Photo Nos. 6 and 7 within the gate house, is operational with the exception of an abandoned 10-inch reservoir drain. All other valves within the structure are kept in the open position and the flow is controlled by valves at the downstream end of the pipeline. The blow-off valve and pipe shown in Photo Nos. 8 and 9, which are currently used as the reservoir drain, are operational. The field stone intake channel shown in Photo Nos. 1 and 3 was partially obscured by water but appeared to be in good condition.

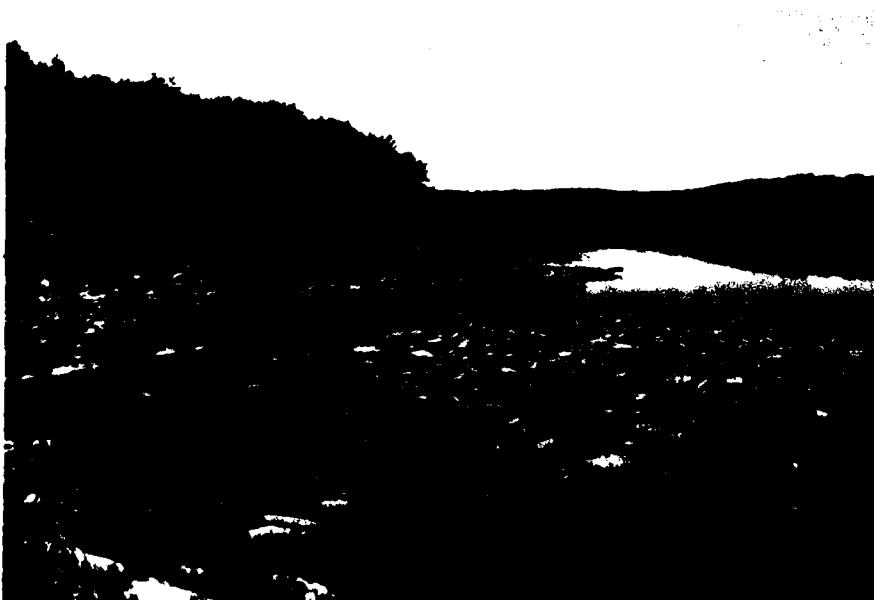
3. INTAKE CHANNEL TO GATE HOUSE.

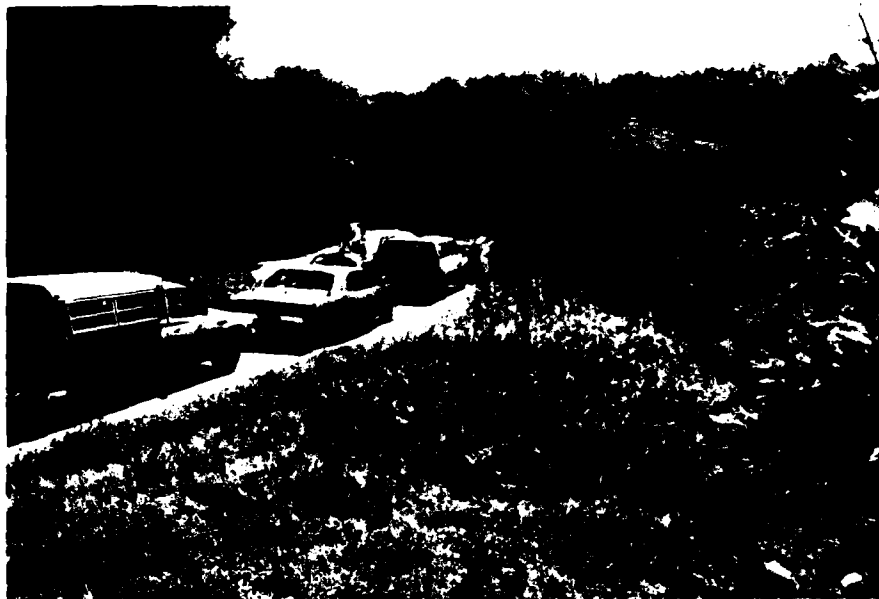
4. CREST OF LEFT DAM EMBANKMENT AND GATE HOUSE.

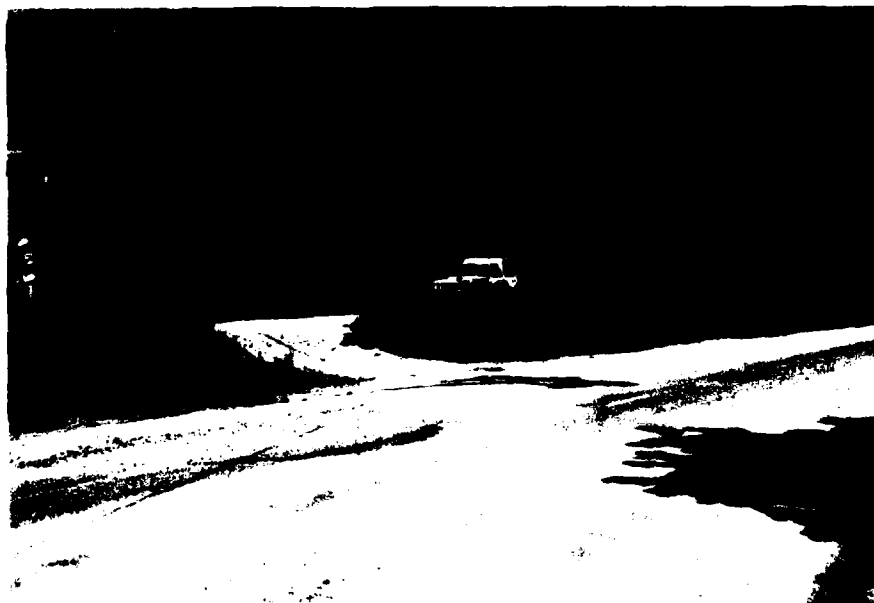
5. VIEW OF LEFT DAM EMBANKMENT FROM ROAD DOWNSTREAM
AND PARALLEL TO DAM.
